PUNJAB ROADS & BRIDGES DEVELOPMENT BOARD

INCEPTION CUM MONTHLY PROGRESS REPORT (NOVEMBER 2014)

**Monitoring of Output and Performance Based Road Contract (OPRC) for Sangrur Mansa
Bathinda Network in Punjab (India)
Contract Agreement No. 1 of 2014-15**

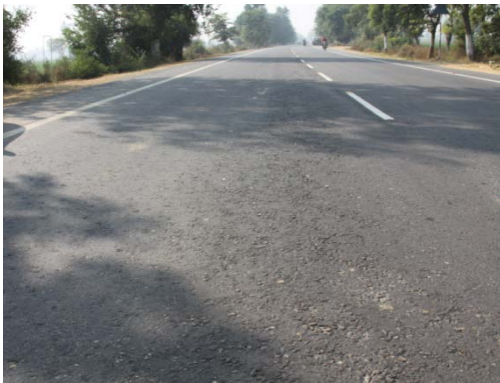
The initial visits to the various sectors revealed presence of cracks, segregation, patching on pavements, asphalt deficiency on specific sites, rutting, and lateral bulging, implying DEFECTS.

Figure 1-2 : Sector S2 - Raveling km 16+940

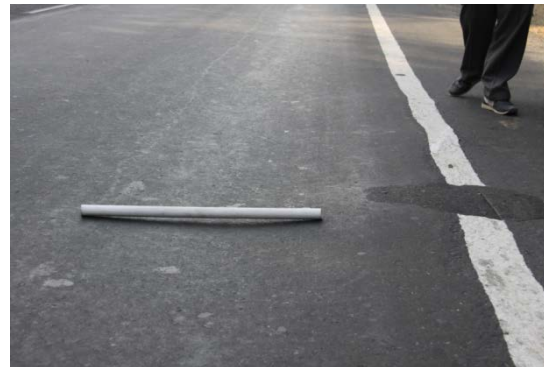
Figure 1-3 : Sector S2 – Rutting – k79

| <p>S2 Km 79+050 (RHS)</p> | <p>RUS&CPM-1</p> | <p>Deflection Found on New Surface</p> | | <p>Rectify the deflection area</p> | <p>marking</p> |
| <p>S2 Km 79+000 (RHS)</p> | <p>RUS&CPM-1</p> | <p>Deflection Found on New Surface</p> | | <p>Rectify the deflection area</p> | <p>Rectify the deflection area to avoid accidents</p> |

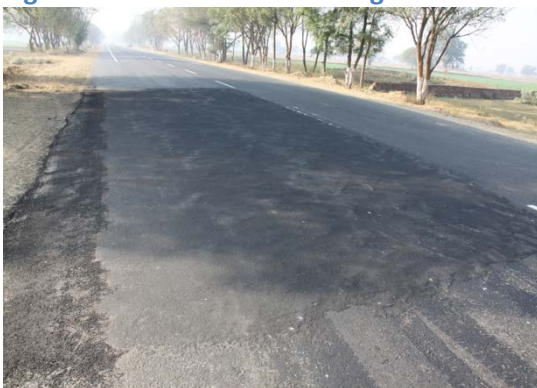
Figure 1-4 : Sector S4 – Patching km 14+000

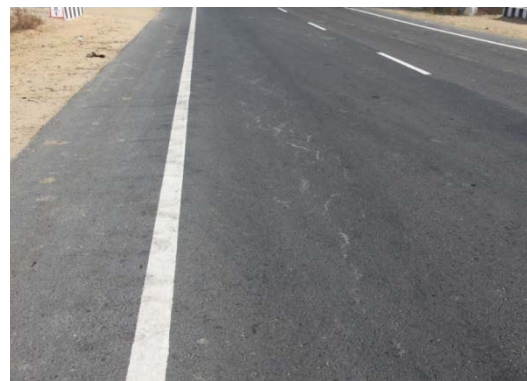
Figure 1-5 : Sector S2 – Cracking – km 7+300

| <p>S2 Km 7+300 (RHS)</p> | <p>RUS&CPM-1</p> | <p>Small Cracks</p> | | <p>The cracks soon will become in pothole, increasing the danger to road users</p> | <p>Required Fog spray</p> |
| <p>S2 Km 7+300 (RHS)</p> | <p>RUS&CPM-1</p> | <p>Small Cracks</p> | | <p>The cracks soon will become in pothole, increasing the danger to road users</p> | <p>Required Fog spray</p> |

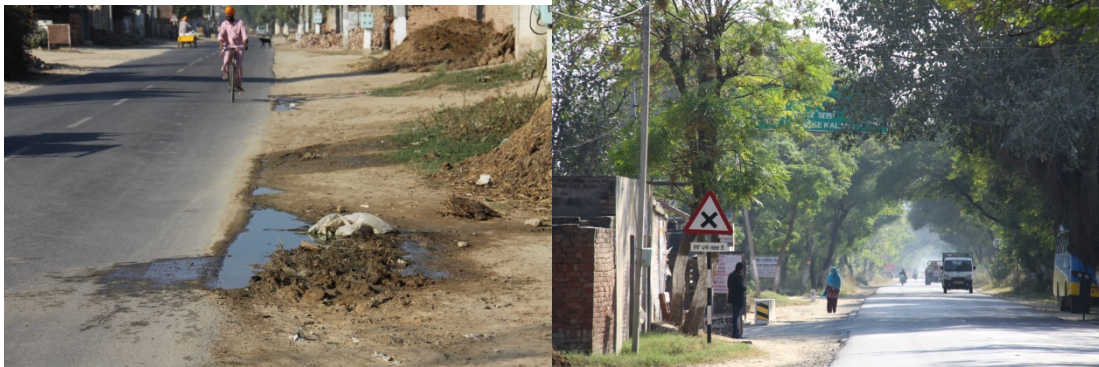
VEGETATION CONTROL: On many sectors of the network, vegetation and the trees obstruct both of the visibility of the road and that of the road signages, which must be in line with the specifications of the contract.

Figure 1-6 : S5 - Water and Marking

Figure 1-7: S5 – Cut Vegetation – Km 10 +500

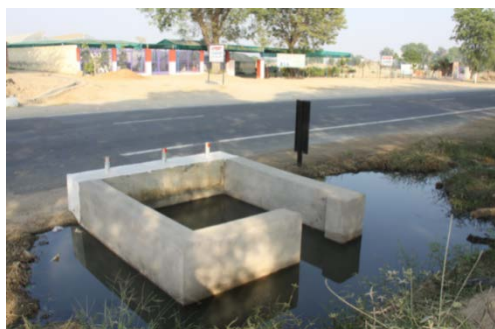
DRAINAGE MAINTENANCE Large number of cross drains and others drains are wholly or partially obstructed, resulting in stagnation of the water and subsequent infiltration which in turn may damage to the pavement structure.

Figure 1-8 : Sector S2- Culvert clogged - K 71+800

| <p>S2 Km 71+800 (RHS)</p> | <p>RUS&CPM-7</p> | <p>Defect Culvert clogged</p> | | <p>Remove Vegetation and required cleaning</p> | <p>Remove Vegetation required cleaning</p> |

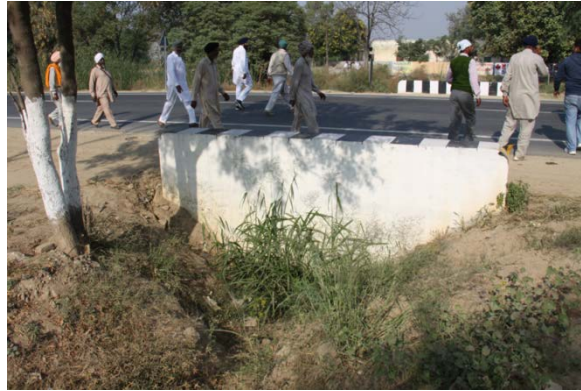
Figure 1-9 : Sector S2- Culvert clogged - K 77+350

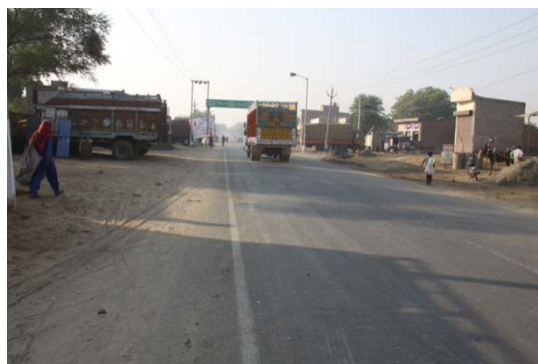
MARKINGS It may be mentioned that in accordance with clause 15.13.2 of the contract, the Contractor must at its own cost ensure proper markings as and when required and as per with the provisions of the standard IRC 35 -1997.Non conformances were reported in this respect as well,

Figure 1-10 : Sector S3 - Marking lost

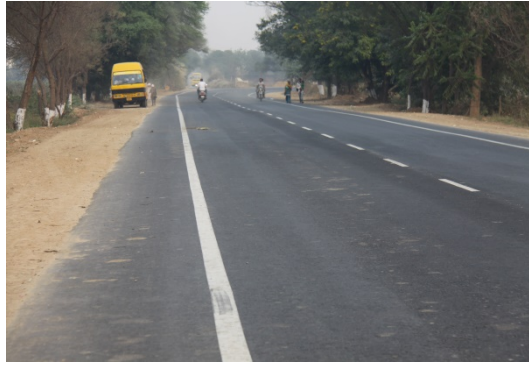
Figure 1-11 : Sector S4 – Without Signs of warning in curve
